# IMPROVING ORGANIC REDUCTION AND OVERCOMING CHALLENGES OF A MEMBRANE BIOREACTOR (MBR) TREATING WASTEWATER FROM PLASTIC PRODUCTION

*Dave Holland, Aqua-Aerobic Systems, Inc. (AASI), 6306 N. Alpine Rd, Rockford, IL 61111, [dholland@aqua-aerobic.com](mailto:dholland@aqua-aerobic.com), 815-639-4470*  
*Ben Antrim, Koch Membrane Systems, Inc., Wilmington, MA*

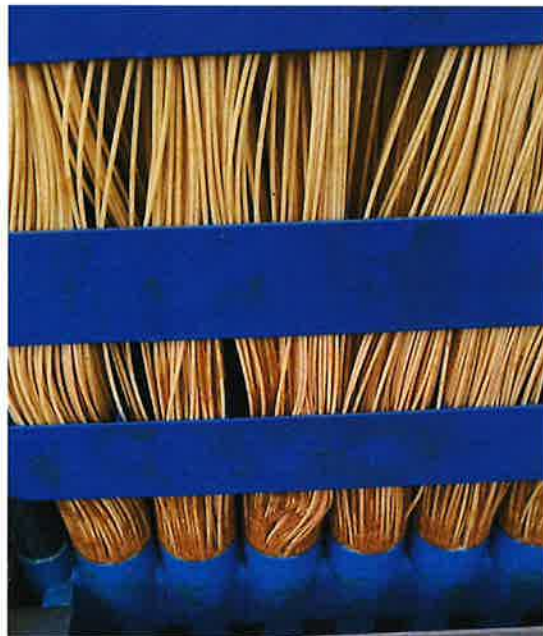
In late-January 2015, trans-membrane pressures (TMPs) started to climb for no apparent reason. It was suspected that the membranes were plugging with solids, so the permeate and air hoses for one of the modules were disconnected, and the module was lifted out of the MLSS and inspected (see Figure 10). Sludging wasn't excessive but certainly more than expected after only 6 months of operation. The module was flushed with a hose to remove the sludge, and returned to service.

**Figure 10. Module Showing Early Signs of Sludging**

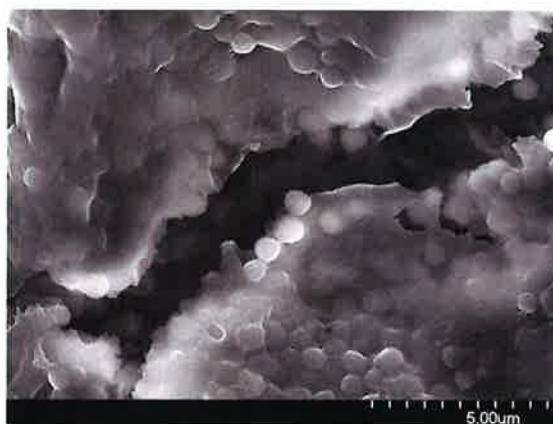
Another possible cause could be EPS in the biomass, excreted by microorganisms under some type of stress, typically nutrient deficiency. Though there was no indication that the plant's nutrient addition systems had malfunctioned, the sludge on the fibers was slimy, a characteristic of EPS fouling, as shown in Figure 11.

**Figure 11.** Magnification of Typical EPS Slime Layer

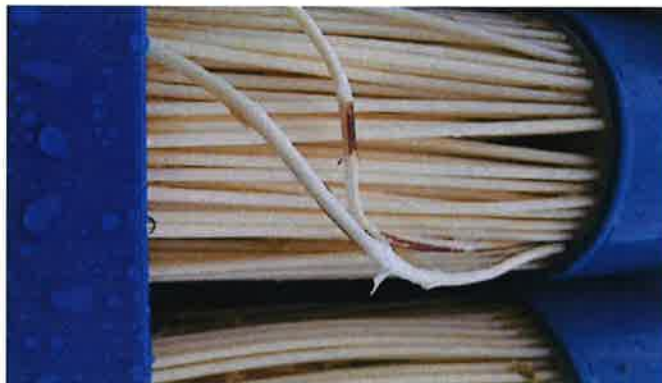
Just as the system showed its first signs of improvement, an unexpected side effect occurred: the weight of the sludge within each fiber bundle in combination with the slimy nature of the sludge caused some of the fiber bundles to fall down and out of the frame. As the fibers flopped over the lower part of the frame, some of the fibers were sliced open, as shown in Figure 12. This required lifting the module out of the biomass and plugging the affected fibers so that the biomass wouldn't bypass the membrane and contaminate the permeate.

**Figure 12. Fibers Sliced by the Lower Module Frame**

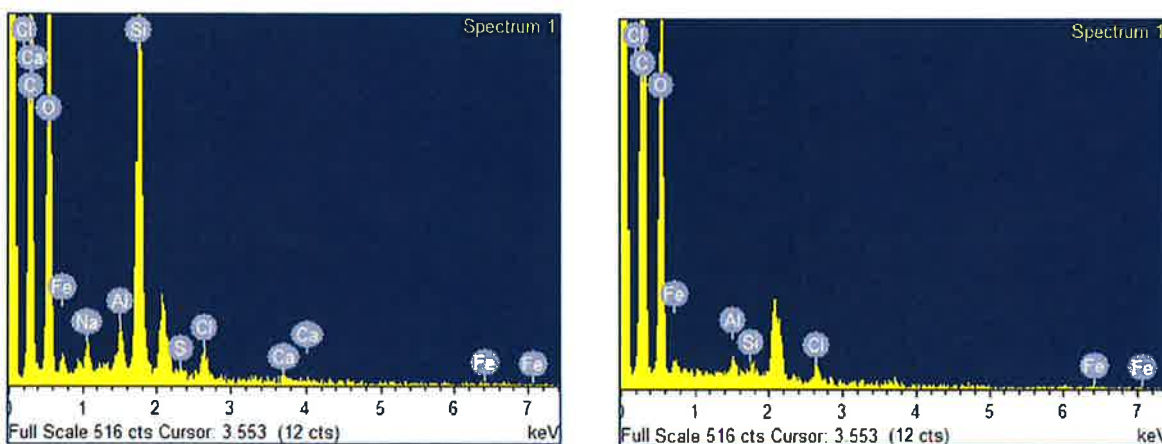
To avoid plugging the new membranes in the same way as the original membranes, it was very important to determine exactly what caused the fouling. The next step in the troubleshooting process was for KMS to analyze the fiber samples for the contaminant(s) causing the issue. The first analysis was with an SEM/EDX technique [Rabiller-Baudry (2012)]. Figure 13 shows a high silicon (Si) level in the foulant gel but a much lower Si concentration on the fiber surface itself. The analyses show only the elemental Si and not what form it's in, so further analyses would be needed to discover the type of Si present. What was revealed was that, if Si is the problem, it's almost exclusively in the foulant; once the foulant is removed, the situation will be much improved. This may explain how most of the original membrane capacity was recoverable.

**Figure 13.** Results from SEM/EDX Analyses of Foulant (left) and Fiber (right)

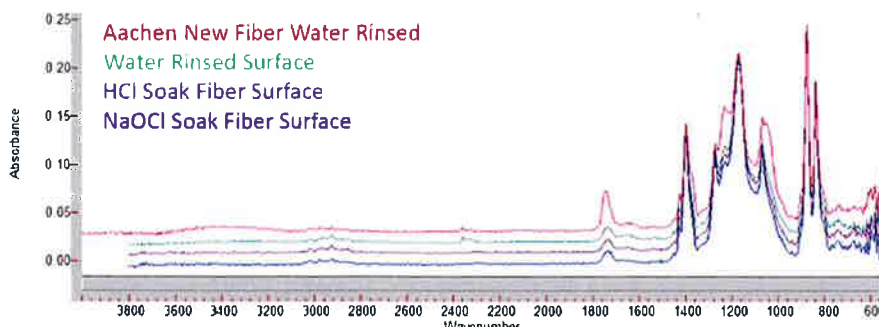
KMS then analyzed the composition of the fiber itself using the FTIR technique [Rabiller-Baudry (2012)]. Figure 14 indicates that a fiber sample analyzed before and after cleaning has a composition that is nearly identical to that of a new fiber. This confirms that the culprit contaminant is not found in any significant concentration within the membrane itself but resides almost exclusively in the foulant gel on the fiber exterior.

**Figure 14.** Results from FTIR Analyses of New and Fouled Fibers, Rinsed and Cleaned

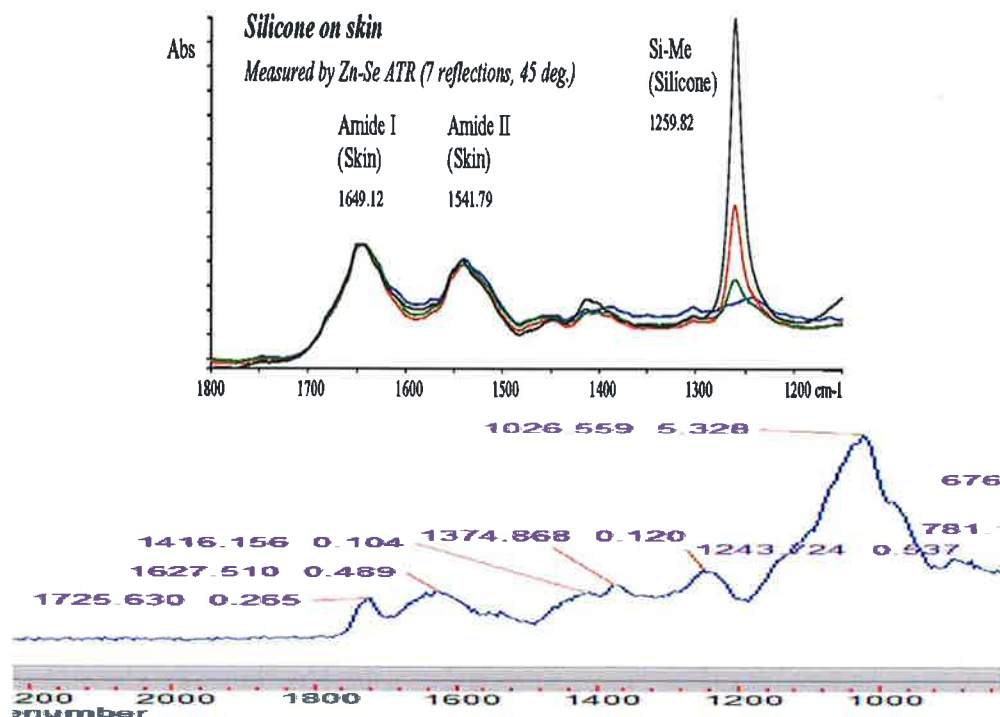
KMS then analyzed the composition of the foulant gel using the FTIR technique to try to determine the exact form of the Si. Figure 15 shows that the foulant sample has a similar – though not exact - composition to that of silicone.

Figure 15. Results from FTIR Analyses of the Foulant (bottom) and of Silicone (top)

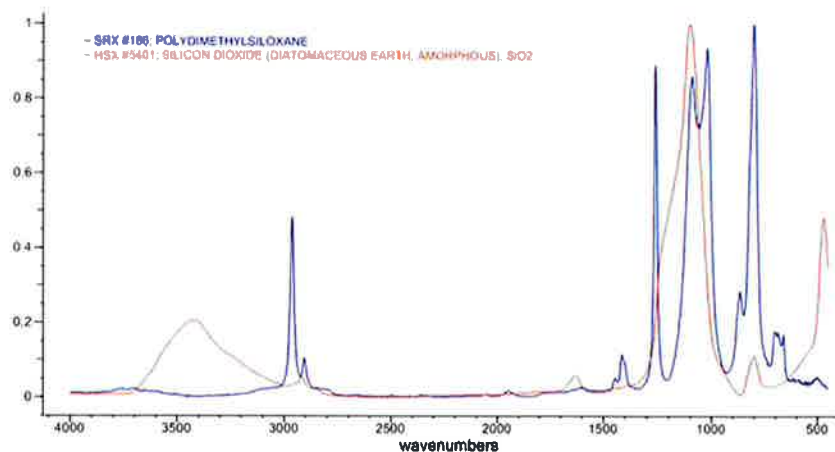
Not satisfied that the foulant composition matched that of silicone, the plant engineers consulted their own in-house experts and discovered a far better match with silicon dioxide (SiO<sub>2</sub>) – refer to Figure 16. Unlike silicone, SiO<sub>2</sub> is prevalent in many wastewaters and is completely compatible with polymeric membranes; therefore, it's not what caused the membrane fouling.

Figure 16. Comparison of the FTIR Analyses of SiO<sub>2</sub> (orange) and of Silicone (blue)

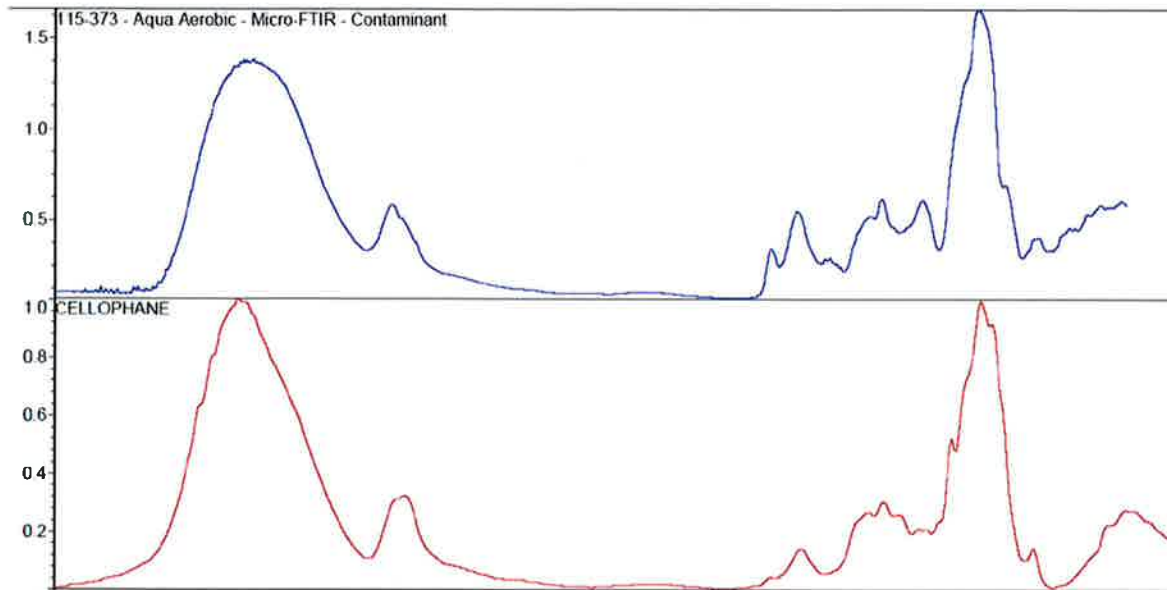
Because of the discrepancy, a foulant sample was sent to an independent lab, Atrona Labs, for FTIR analysis. Atrona concluded that the foulant most closely matches that of cellophane, as shown in Figure 17.

**Figure 17.** Comparison of the FTIR Analyses of Cellophane (orange) and of the Foulant (blue)

Cellophane is produced from cellulose using an acidification process. Cellulose occurs naturally in trees and plants, but can also be synthesized through the breakdown of glucose by the *Acetobacter xylinum* bacteria [Cheng (2002)]; therefore, it's technically an EPS. The creation of a significant amount of cellophane in a plastic production facility or its wastewater treatment plant would have to be the “perfect storm”, maybe even a literal storm: perhaps a very large tree limb or bunch of branches falls or blows into an equalization or aeration basin, and an equally-significant amount of acid is present in the basin to create the cellophane. One of the sources of wastewater in the plant contains 500-1,000 mg/l of acetic acid, but it's questionable that this would be enough to produce a damaging amount of cellophane. And to make the scenario even more unlikely, cellophane is very biodegradable, so most – if not all – would be degraded before it reached the membranes. A far more possible reason for the presence of cellophane in the wastewater is that cellophane wrapping material was improperly discarded/placed in the wastewater.
