FIRST ON-DEMAND POTABLE CERAMIC MEMBRANE SYSTEM IN U.S. MINIMIZES ENERGY AND WASTE

Dave Holland, Aqua-Aerobic Systems, Inc, 6306 N. Alpine Rd., Loves Park, IL, 61111

Nathan Kutil, P.E., HDR Engineers, Missoula, MT, 59803

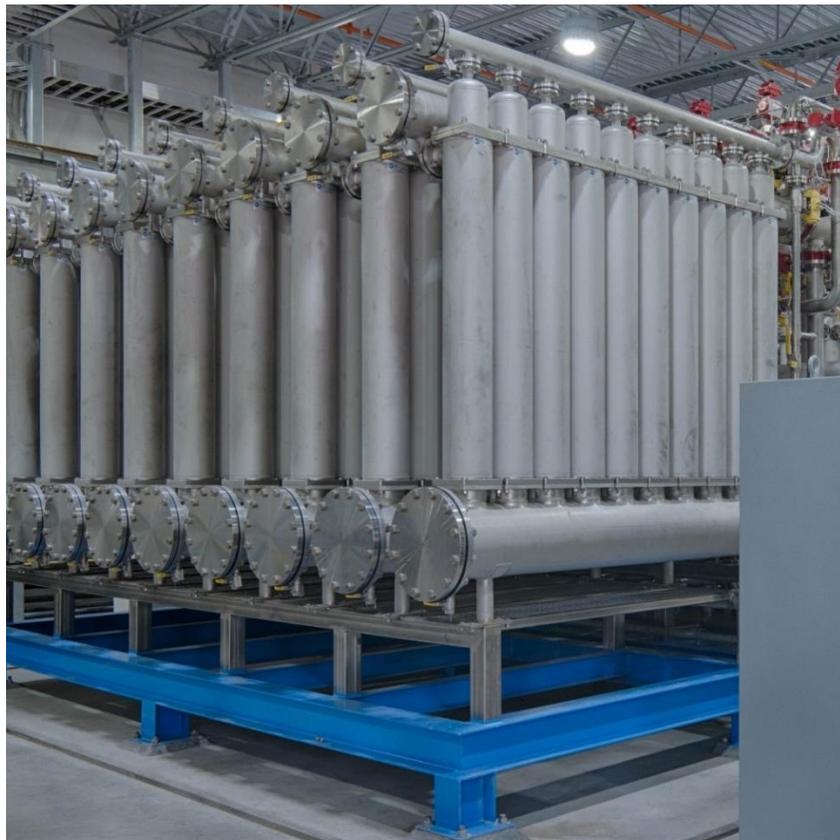
Figure 5 Primary Ceramic Membrane System Skid (One of Four)

The primary ceramic membrane system consists of four 100-module skids (400 modules total), each with ten rows of ten Aqua MultiBore® C-Series ceramic modules. Figure 5 shows one of the skids.

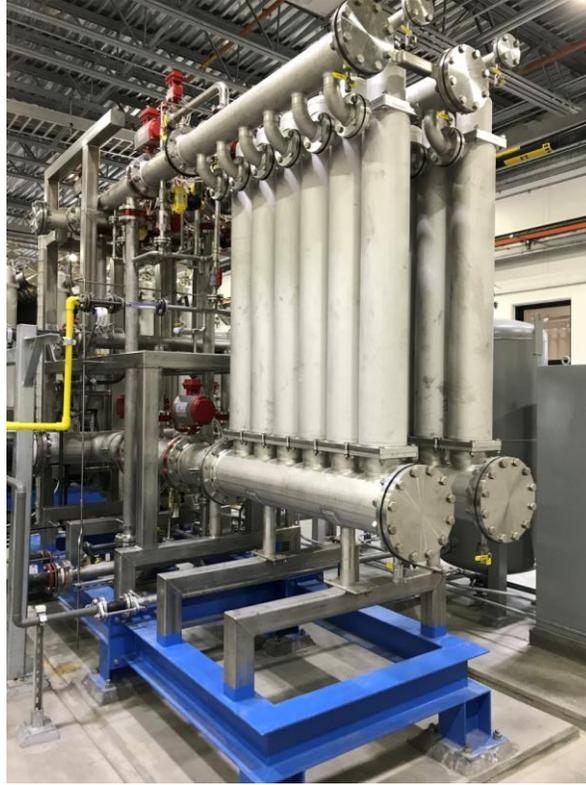
Figure 6 Backwash Recovery Ceramic Membrane System Skid

The backwash recovery ceramic membrane system consists of one 12-module skid with two rows of six C-Series ceramic modules, as shown in Figure 6. Each of the five membrane skids includes an air receiver and backwash tank sized for backwashing one row at a time. Also provided was a three-tank CIP system designed to clean up to five rows (fifty modules) at a time. The entire system was manufactured, delivered, installed, and started up by May 2017.

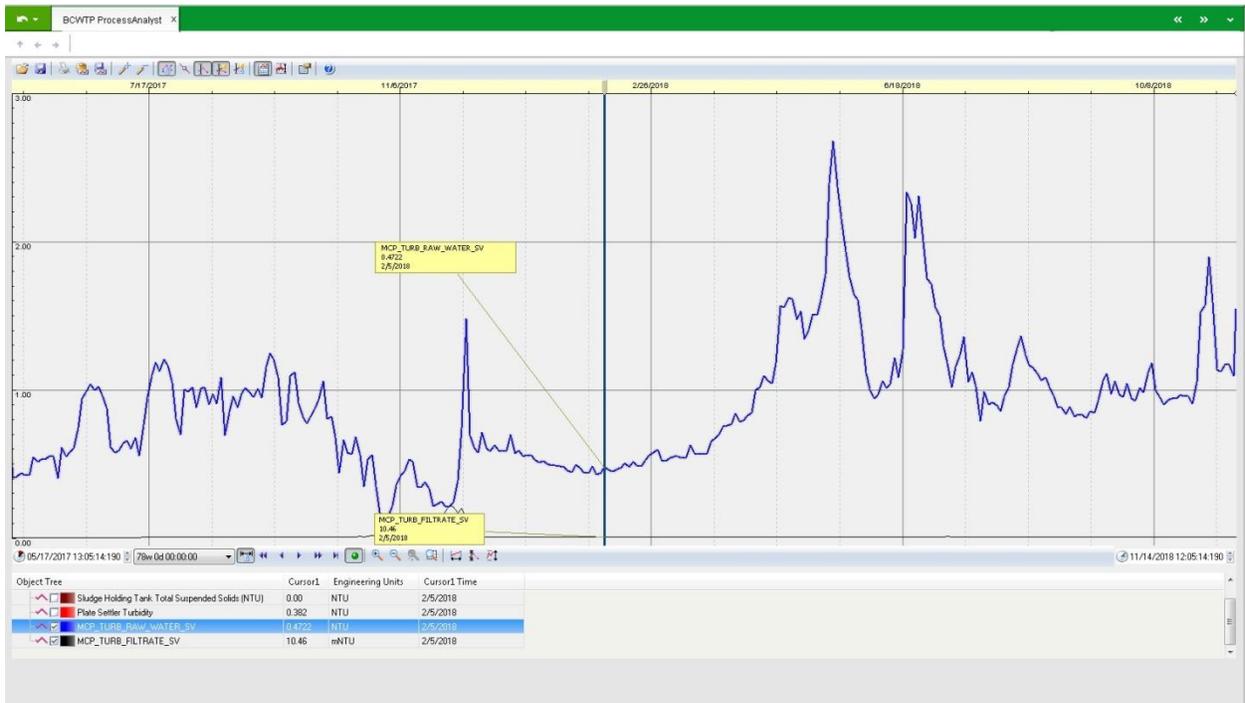
Figure 8 Primary System Turbidities during the First 19 Months of Operation

Figure 8 shows the influent and effluent turbidities for the primary ceramic membrane system during the first 19 months. The influent turbidity ranged from 0.1 to 2.7 NTU, while the effluent turbidity was consistently around 10 mNTU (0.01 NTU). The permeability of each membrane train during this same period is given in Figure 9; as shown, permeabilities varied from 9 to 23 gfd/psi, typically increasing as the flow through the system decreased and following the CIP in June of 2018.

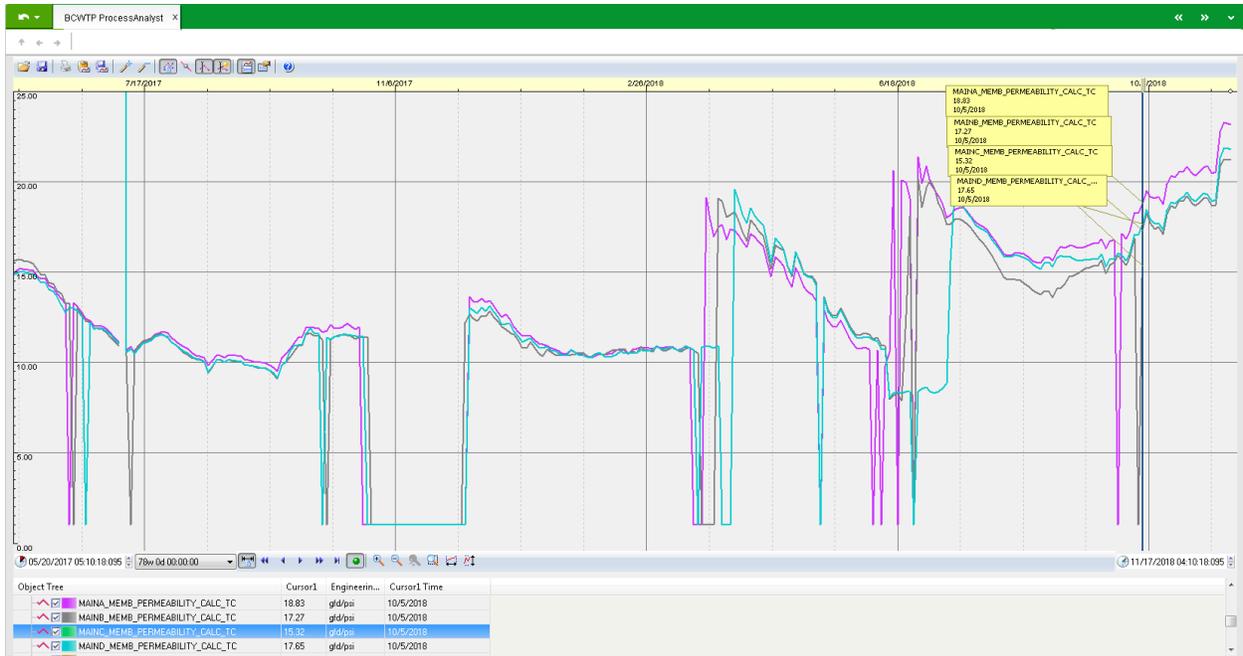
Figure 9 Primary System Membrane Permeabilities During the First 19 Months of Operation

During the first attempt at a CIP, the CIP caustic pump failed so that only the acid portion of the CIP was performed initially – this can be seen in Figure 9 on the previous page, where the permeabilities increased in March 2018, following the acid CIP, and then later in June following the caustic CIP.

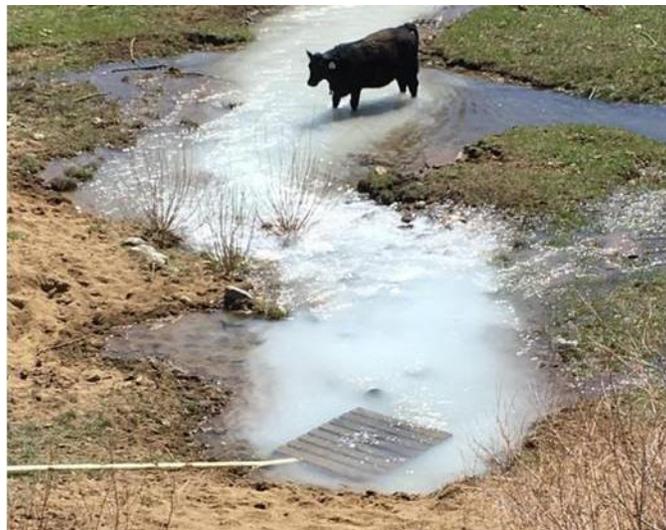
Figure 10 Entrained Air in Basin Creek

Several problems were encountered during the first nineteen months of operation. For instance, the filtrate during startup was being diverted to a drain discharging to a nearby creek, and it was noticed that the creek contained an excessive amount of entrained air, as shown in Figure 10, but the effluent turbidities were below the 0.1 NTU alarm setting.

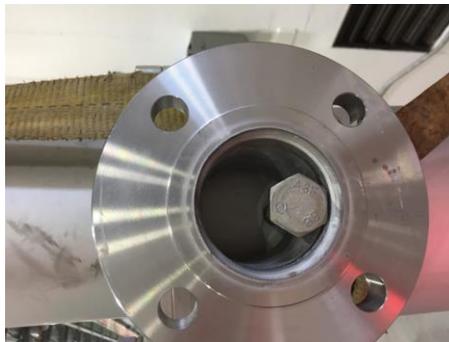
Figure 13 Bolt Discovered in Filtrate Line

In September 2018, one of the primary ceramic membrane rows failed its air integrity test. Since the backwash pressure (70 psig) is fairly high for a low-pressure membrane system, there is not a clear section of pipe on each module's filtrate line as there is on most of other MF/UF systems; therefore, the module with the air leak had to be determined by listening for the air bubbles using a sonic detection device (a common stethoscope works well). Once the faulty module was identified, the piping was disconnected from the module (in order to remove the module), and a bolt was discovered in the filtrate line, as shown in Figure 13.

Because all of the modules and piping had been installed at the factory, and the plant had not disconnected the piping since that time, the bolt must have been left in the line during pipe fabrication. Though each line was flushed with clean water prior to loading of the ceramic elements, the flush water flow was not enough to push the bolt out; however, the backwash flow during operation was of sufficient velocity to project the bolt into the side of the ceramic element with a force that eventually chipped away at the material on the outside of the element.

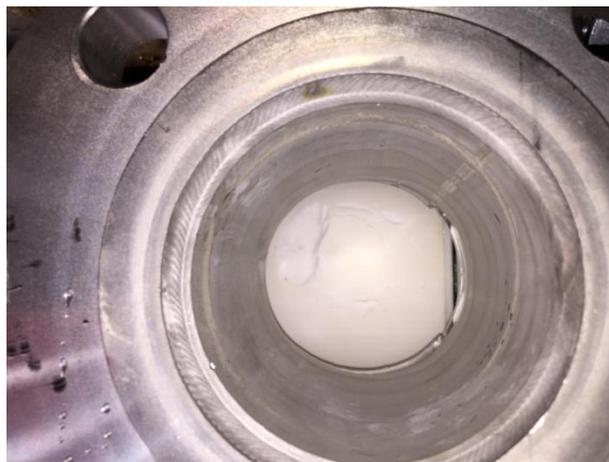
Figure 14 Damage to Ceramic Element

During each backwash, the bolt was propelled into the side of the element until it eventually chipped a hole big enough for air to pass through the membrane during an integrity test. Figure 14 shows where the bolt chipped the element at the spot where the filtrate first enters the module during a backwash.
