# **NO-BREAK FIBER SOLVES MEMBRANE INTEGRITY PROBLEMS AT FIVE WATER TREATMENT PLANTS**

*Dave Holland, Aqua-Aerobic Systems, Inc., 6306 N. Alpine Rd, Rockford, IL 61111,  
[dholland@aquaaerobic.com](mailto:dholland@aquaaerobic.com), 815 639-4470*

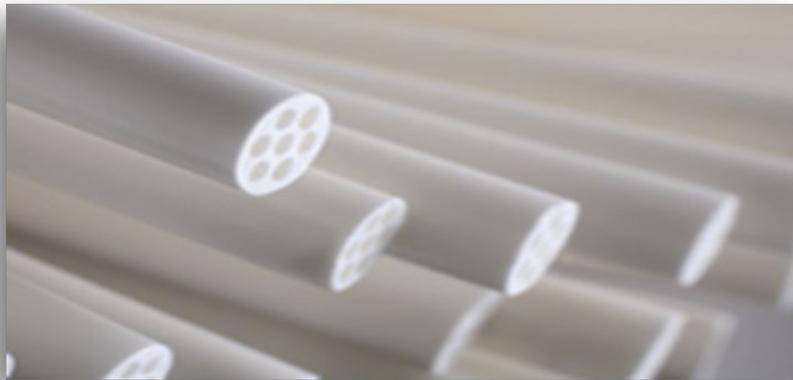
The primary reason the plants made the switch to these membranes was because of their unique honeycomb-like construction, as illustrated in Figure 1. While almost all other hollow-fiber membranes use fibers with single-bores, this fiber is made with seven bores such that it's essentially seven fibers in one. This gives the fiber strength that a single-bore fiber doesn't have. In addition, the multi-bore fiber is made from a single material with different porosities throughout the membrane structure. Many membranes made of two materials – with the membrane material layered on the outside of a support structure – are very strong, but the outer membrane layer has a tendency to pull away from the support layer over time (delaminate) under the stresses caused by repeated air scours.

**Figure 1.** Multi-bore Fibers

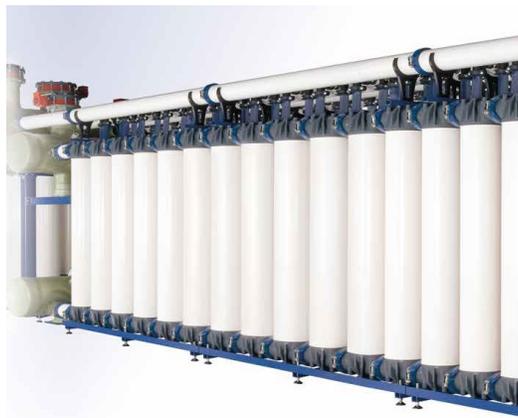
**Figure 4.** Typical Multi-bore Membrane Assembly

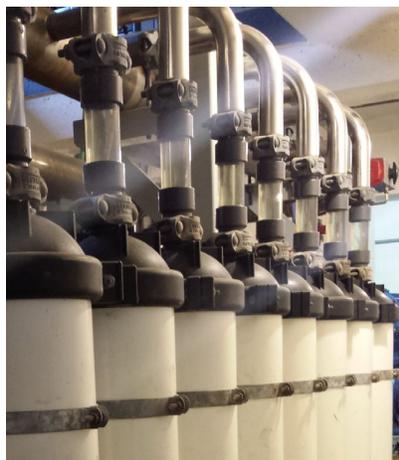
**Figure 8.** Original Butler Membrane Modules with Clear Filtrate Piping

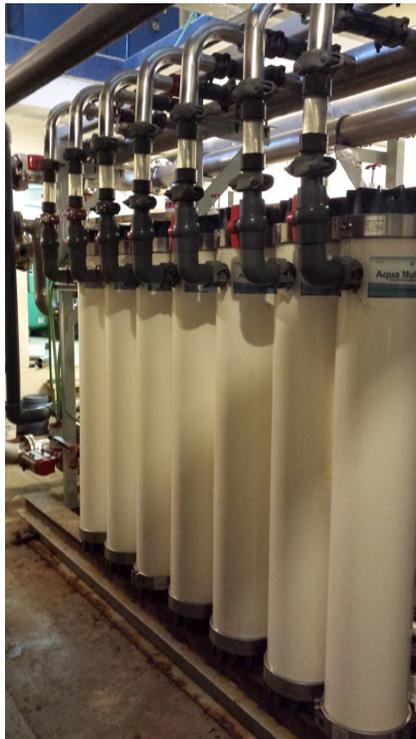
Because the modules were the same ones used in the original membrane system at the Butler plant, they experienced some of the same integrity issues. However, the problem was more serious at the Garden City plant since they only had two membrane trains and were forced to stop the flow entirely whenever they had integrity issues in both trains at the same time. Therefore, when they saw that the Butler plant had successfully replaced their modules with the multi-bore fibers, they were interested in doing the same. So in 2014, the eight modules in one train were replaced with seven Aqua MultiBore® P-Series Polymeric Membrane modules, leaving in operation the second train as well as the original membrane racks, backwash pumps, CIP system, and PLC program. The filtrate connection to each module was moved from the top of the module to its upper sidesheet, as shown in Figure 13. Because the new modules contained 30% more filtration area than the original modules, (7) of the new modules provided 14% more area than the (8) original modules; the train connections for the eighth module were plugged.

**Figure 13.** The New Garden City Modules with Rerouted Filtrate Piping

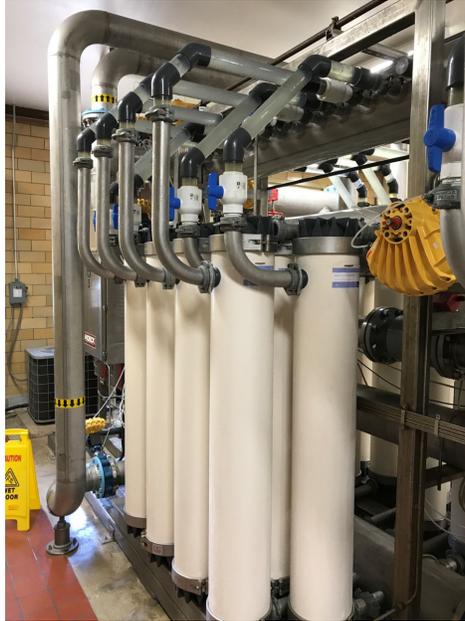
The original Two Rivers modules were the same ones used in the original membrane systems at the Butler and Garden City plants; therefore, they experienced some of the same integrity issues shortly after commissioning. When they heard that this same membrane was replaced successfully at the other facilities, they proposed to the Wisconsin Department of Natural Resources (WDNR) that the modules in one of their trains be replaced with the multi-bore membranes. The WDNR agreed under the stipulation that an AIT first be performed on a single module with an intentionally-cut fiber to verify that the module would fail the test. This test was performed successfully in late 2016, and the modules in Train 5 were replaced in 2017. Only 35 of the new modules were needed because these had the same total area as the 45 original modules; the train connections for the other 10 modules were plugged. Because the train area remained the same, the original membrane racks, backwash pumps, CIP system, and PLC program could be used for the new modules. As with the other retrofits, the filtrate connection to each module was moved from the top of the module to its upper sidesheet, as shown in Figure 16. Note that the configuration is slightly different as each Two Rivers train contains four rows in lieu of the two-row trains at Butler and the one-row trains at Garden City.

**Figure 16.** The New Two Rivers Modules with Rerouted Filtrate Piping

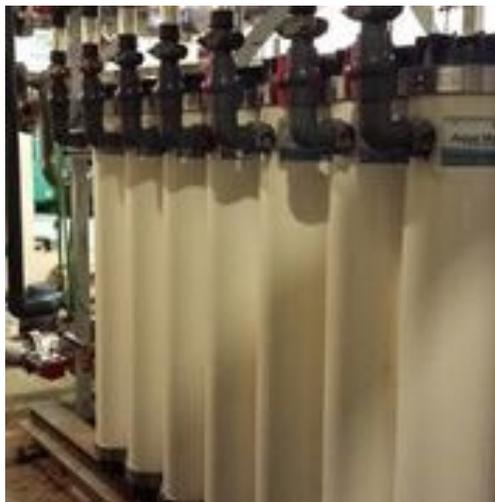
Once they learned of the successes at the Butler and Garden City plants with the multi-bore fibers, they began working with Aqua-Aerobic Systems to retrofit their modules. Since the MDNR had already approved the membrane for the other two plants, and the plants had been using the membranes for several years, the State allowed the plant to replace all of the modules at one time such that the 1-month demonstration was performed on both trains. So in 2018, the sixteen modules in both trains were replaced with fourteen Aqua MultiBore® P-Series Polymeric Membrane modules, leaving in operation the original membrane racks, backwash pumps, CIP system, and PLC program. The filtrate connection to each module was moved from the top of the module to its upper sidesheet, as shown in Figure 20, and plugs were provided for the connections at the empty module location on each train.

**Figure 20.** The New Amsterdam Modules with Rerouted Filtrate Piping

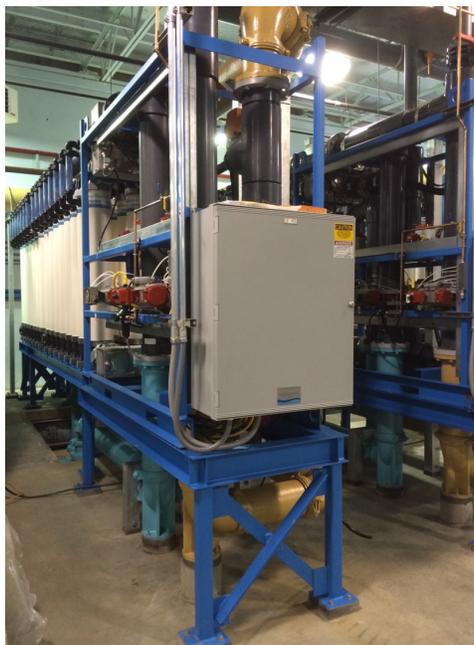
To help them find a better membrane, the Village hired URS Engineers (now part of AECOM), who suggested they look at several other membranes, including the Inge multi-bore membrane. The State regulators approved a 2,000-hour demonstration during which the new system would operate in parallel with the existing system to verify the new system could achieve the desired effluent quality with no fiber breaks. The project was competitively bid in 2013, and the Village decided to go with the Aqua MultiBore P-Series system because of its demonstrated integrity and 5-year no-break warranty. The new system – consisting of (3) 30-module trains – was placed in operation in 2014; instead of running in parallel with the existing system, however, the new system quickly became the only operating system because the plant was unable to keep the existing trains in service due to the frequency and magnitude of fiber repairs.

**Figure 23.** One of the New Byesville Membrane Trains
