# IMPROVING ORGANIC REDUCTION AND OVERCOMING CHALLENGES OF A MEMBRANE BIOREACTOR (MBR) TREATING WASTEWATER FROM PLASTIC PRODUCTION

*Dave Holland, Aqua-Aerobic Systems, Inc. (AASI), 6306 N. Alpine Rd, Rockford, IL 61111, [dholland@aqua-aerobic.com](mailto:dholland@aqua-aerobic.com), 815-639-4470*  
*Ben Antrim, Koch Membrane Systems, Inc., Wilmington, MA*

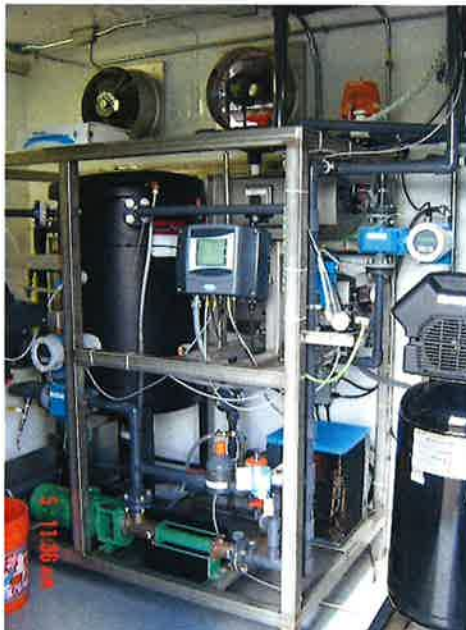
Data was continuously monitored by the pilot instrumentation and recorded by the system's SCADA controls. Figure 5 shows the location of some of the pilot instrumentation. Trends for each of the major parameters are shown in Figure 6. Note that the TMP remained below 2 psi for almost the entire test and averaged less than 1 psi; this indicated that the membrane operation was fairly stable under each of the test phases. Spikes in TMP seemed to correlate with dips in pH, so soda ash was added during the final two phases to keep the pH above 6. Increasing the membrane tank MLSS for the final two phases increased the TMP to about 3 psi, but stable operation was still achieved.

**Figure 5. Photo Showing Some of the AASI Pilot Instrumentation**

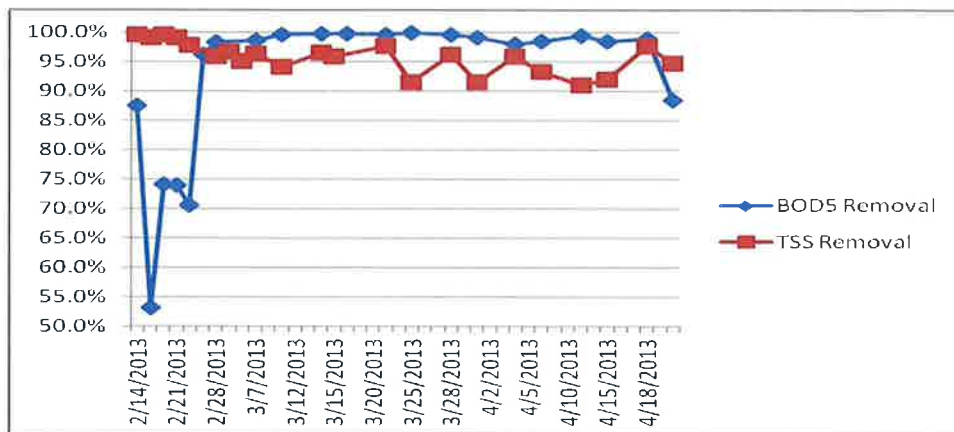
Figure 7. AASI Pilot Performance

Figure 7 shows how the pilot performed with regards to BOD<sub>5</sub> and TSS removal. During the first test phase, BOD<sub>5</sub> removal was sporadic. During phases 2 - 8, BOD<sub>5</sub> removal averaged above 99%, reducing influent values from as high as 5,048 mg/l to less than the required 28 mg/l. During the final phase, there was a slight drop in BOD<sub>5</sub> removal, probably due to the lower food-to-microorganism (F/M) ratio that results from a higher bioreactor MLSS.

The TSS removal varied between 90 and 99%; this fluctuation was due to influent values ranging from 25 – 320 mg/l, while effluent values were fairly constant around 3 mg/l, as would be expected with a positive solids barrier.
